D.3 THREE MILE ISLAND

Arranged By: Phathom Donald Electrical Engineering, '14

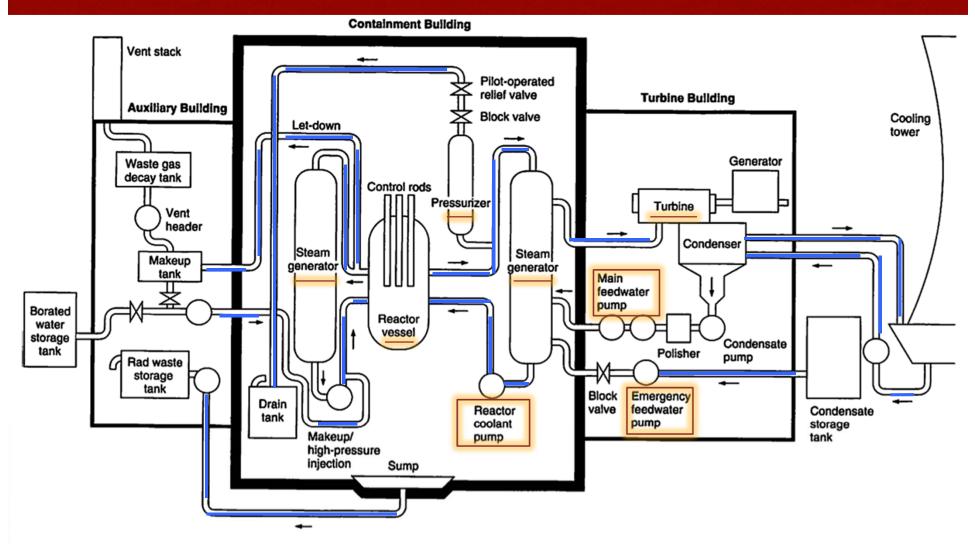
FIGURE D.2

The Three Mile Island nuclear power plant. (Source: John G. Kemeny. *Report of the President's Commission on the Accident at Three Mile Island*, U.S. Government Accounting Office, Washington, D.C., 1979.)

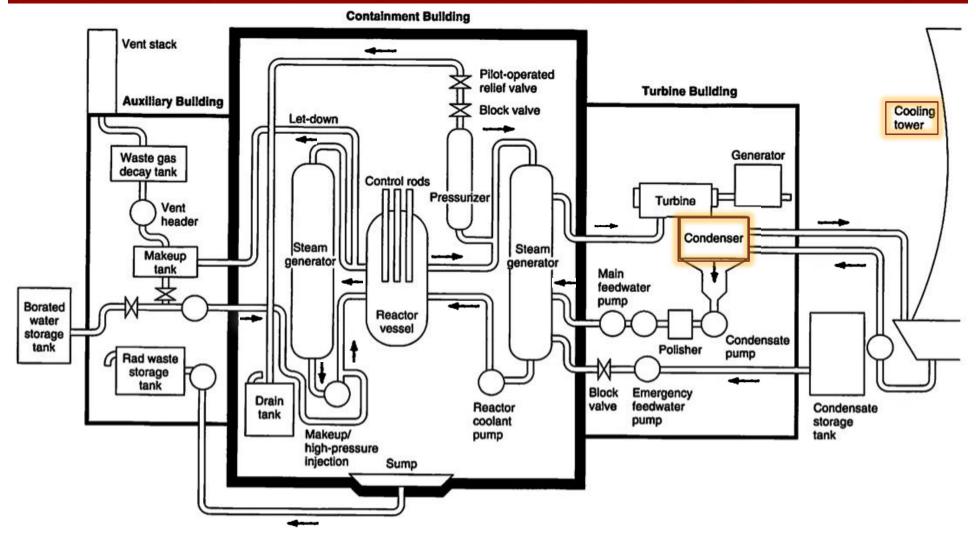
FIGURE D.2

The Three Mile Island nuclear power plant. (Source: John G. Kemeny. *Report of the President's Commission on the Accident at Three Mile Island*, U.S. Government Accounting Office, Washington, D.C., 1979.)

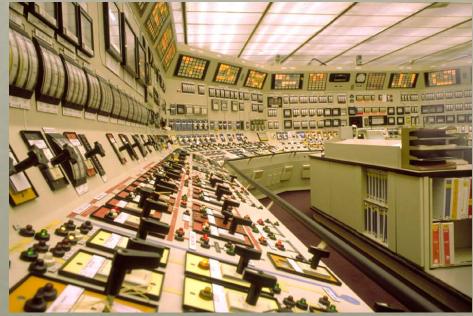
- Control room was not adequately designed with the management of an accident in mind.
- Control room design and information presentation that confused the operators:
 - No way to suppress unimportant signals so that they could concentrate on the important ones
 - Poor arrangement of controls and indicators. Information was not presented in a clear and understandable form.
- John Kemeny of the Kemeny report stated that the technology in the TMI control rooms were "at least twenty years behind in times."
